# **EVAPOTRANSPIRATION FINAL COVERS: THE KANSAS EXPERIENCE – FROM CONCEPT TO REALITY**

**Michael S. Kukuk, PG, Nathan A. Hamm, PE, Susan L. McCart, PE, PG, and Anastasia J. Welch, PE  
Aquaterra Environmental Solutions, Inc., Overland Park, Kansas**

## **ABSTRACT**

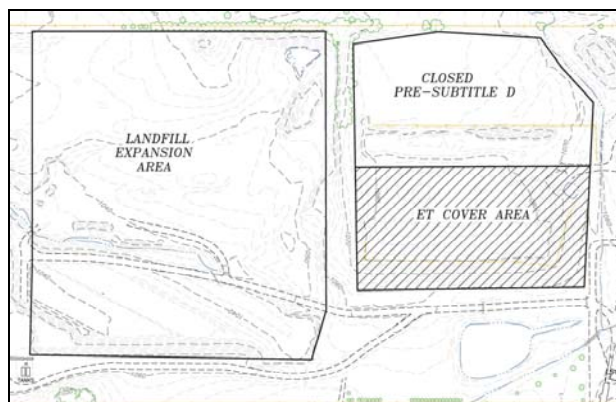
**Figure 1 – Coffey County Sanitary Landfill**

The Coffey County Sanitary Landfill (CCSL) is located just east of Burlington, Kansas in Coffey County. The CCSL is located on approximately 120 acres, of which a total of approximately 38 are permitted for waste disposal. The landfill is owned and operated by Coffey County. The current disposal area consists of 24 acres permitted under Subtitle D requirements. Seven acres of a pre-Subtitle D area was permitted for a Vertical Expansion in 1998. This Vertical Expansion was closed using an ET alternative final cover during the summer and fall of 2003. The following figure (Figure 1) illustrates the landfill property and approximate ET cover boundary.

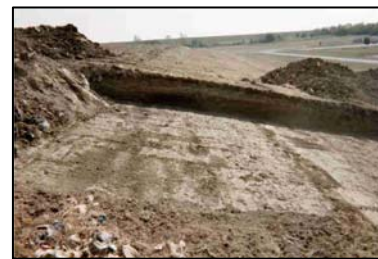
**Subgrade Construction:** The design plans required an 18-inch thick compacted cohesive soil base below the lysimeter pans. The existing in-place intermediate cover in

the two proposed lysimeter areas was in excess of 8 feet; therefore, a 4-foot excavation was made into the cover for lysimeter installation. Elevation surveys were performed to ensure the pan was sloped correctly and the silty-clay material above the base was placed as necessary. The subgrade for each lysimeter was tested for in-place density, which was found to be acceptable.

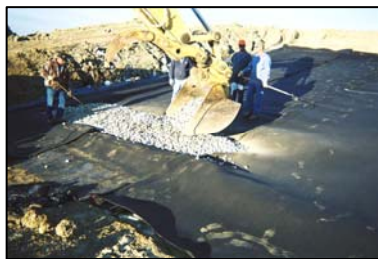
**Drainage Layer Installation:** A double-sided geocomposite drainage layer was installed over the PVC liner in three sections. The roll of composite was placed at the top of the lysimeter and held in place via a bar and two skid loaders. The composite material was then pulled from the roll and placed in the lysimeter with sufficient extra material to overlap the panels and the curbs. The 15-foot wide panels were placed at the sides first, then in the middle with a minimum of 2 foot of overlap between panels.

Drainage rock was placed in the sump area after geocomposite deployment was complete. Geotextile was then placed over the drainage rock to provide a separation barrier from the overlying ET cover soils.

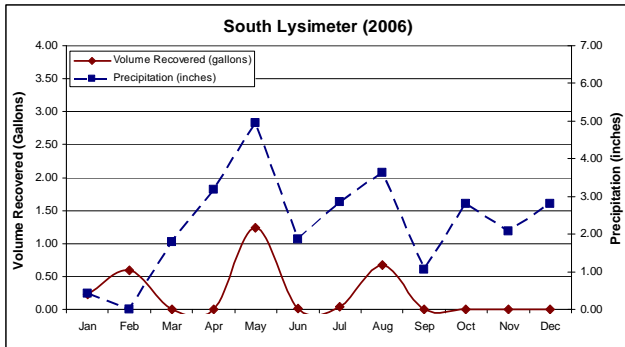
In general, it can be seen that drainage through the lysimeter tends to follow certain trends generally related to seasons. The following three graphs demonstrate the relationship between the timing of rainfall events to the drainage through the lysimeter.

**Graph 3 – CCSL South Lysimeter - 2004 Volume Recovered Compared to Monthly Precipitation**

**Graph 4 – CCSL South Lysimeter - 2005 Volume Recovered Compared to Monthly Precipitation**

**Graph 5 – CCSL South Lysimeter - 2006  
Volume Recovered Compared to Monthly Precipitation**

Modeling results during the ET cover design indicated a maximum of approximately 17 gallons of water would percolate through the cover. This was estimated for a year which followed several years of heavy precipitation. Based on measurements recorded in the South Lysimeter, the ET cover is functioning better than the model predicted.

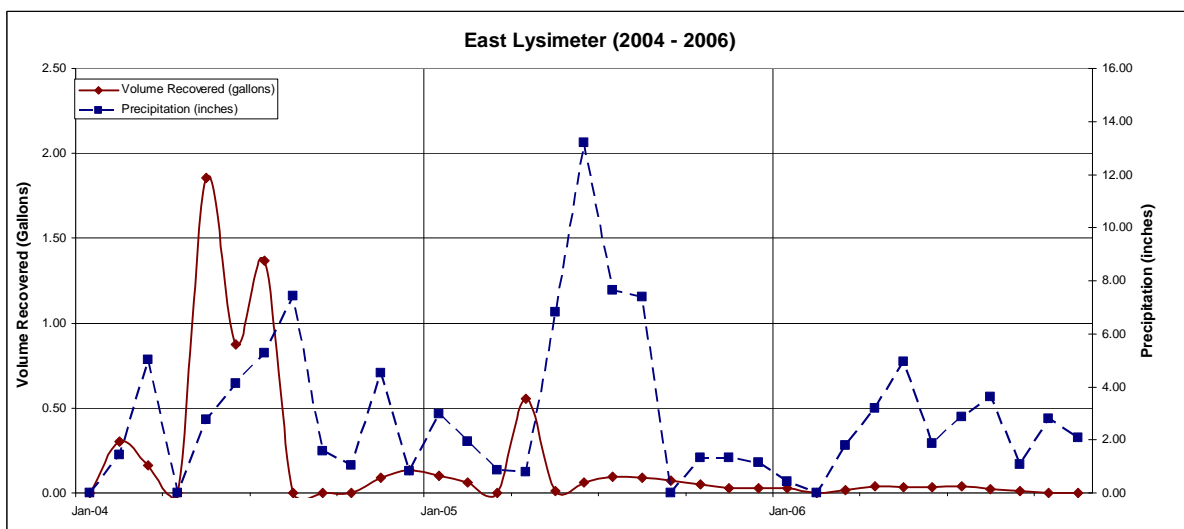
**Graph 7 – CCSL East Lysimeter – Volume Recovered Compared to Monthly Precipitation**

As with the South Lysimeter, the measured volume of water collected in the East Lysimeter indicates the cover is functioning better than the model predicted. The following graph shows all three years of drainage data for the East Lysimeter, combined with the precipitation data for the three-year time period.

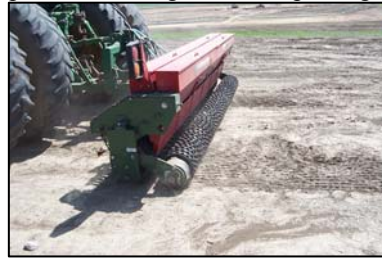
The 1-foot thick topsoil layer was placed in the same manner as the silty-clay. The material was placed such that its moisture and density values fell within the target placement range. After placing the topsoil, 15 tons of

cattle manure were spread over the cover and disked into the upper 6 inches. The manure was expected to increase the organic content of the soil, provide nutrients for

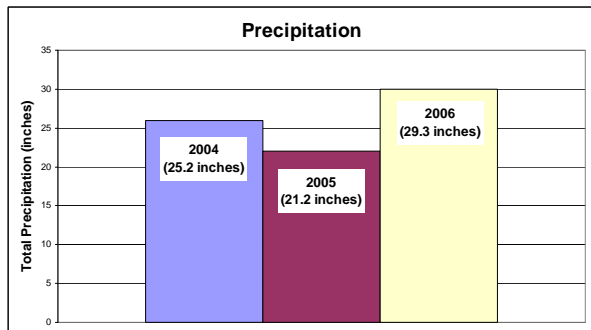
**Graph 8 – Barton County Precipitation**

The total precipitation recorded in Great Bend over the past three years (since ET cover construction) has been variable but within historical normalcy. The graph below summarizes the yearly precipitation.

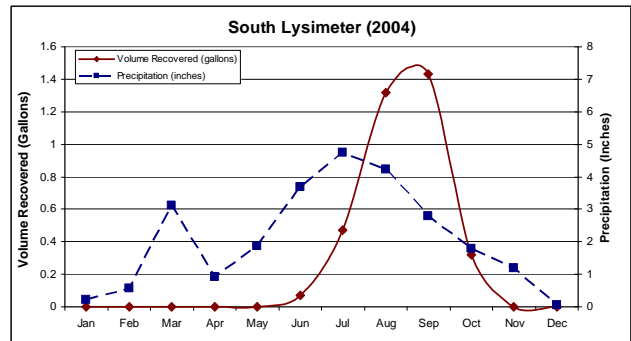
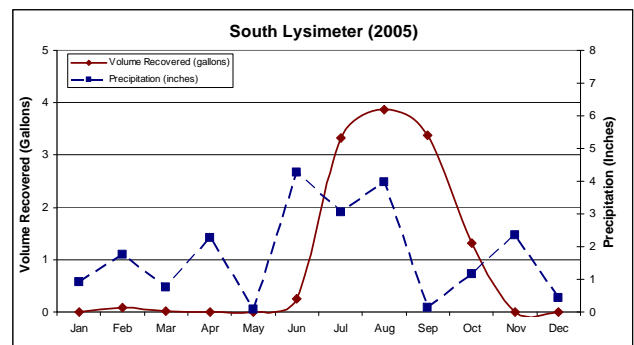
The following three graphs demonstrate the relationship between monthly precipitation totals and drainage through the lysimeter.

**Graph 10 – BCSL South Lysimeter - 2004 Volume Recovered Compared to Monthly Precipitation**

**Graph 11 – BCSL South Lysimeter - 2005 Volume Recovered Compared to Monthly Precipitation**

**Graph 12 – BCSL South Lysimeter - 2006 Volume Recovered Compared to Monthly Precipitation**

Although the volume of water recovered in the South Lysimeter is above the 1.5 gallons per year predicted by modeling, readings have indicated compliance with the design infiltration rate (3 mm/year).

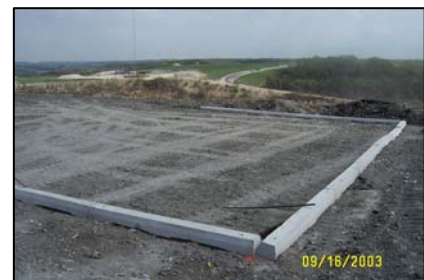
**Concrete and Pan Construction:** Concrete curbs were placed to enclose an approximate 32-foot by 48-foot area for each lysimeter. Each curb was 8-feet long, 8 inches high, 6.5 inches wide at the top, 9 inches wide at the base, and weighed approximately 400 pounds. Two, 15-inch rebar stakes were used to secure each end of each curb into the subgrade. A surveyor located the sump pit, and field laborers excavated an area for the sump using shovels.

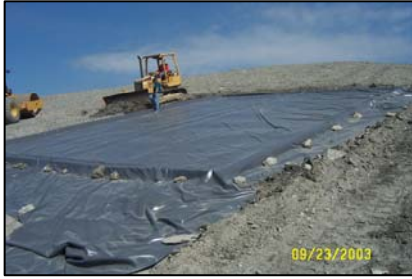
**PVC Liner Installation:** After the subgrade, concrete curbs, and sump pit were constructed, a sheet of factory-welded PVC liner was deployed over each lysimeter base. The PVC panels were pre-fabricated to be 42-feet wide by 60-feet long so the material could overlap the curbs and fit inside the sump. Field welding for adjacent panels was not

required because the individual panels were welded together at the factory to the required dimensions. After deployment, the CQA technician observed the liner for visual defects and holes. No major defects or holes were found on either panel. A hole was cut in the PVC liner to install the outlet pipe in the sump and a PVC pipe boot was glued over the pipe and hole. The fitting edges were caulked with silicone to provide an additional factor of safety against leaking.

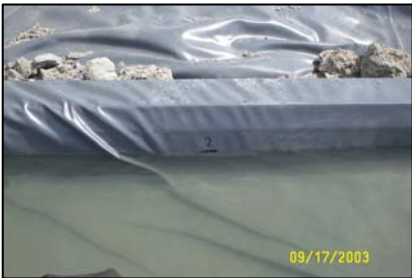
The PVC liner within the lysimeter sumps was leak tested prior to installing the geocomposite drainage material and rock. The leak tests were performed by capping the end of the discharge piping from the sump, adding water to a level that was easily discernable on the sidewalls of the sump, and monitoring the water level for a 24-hour period. The Top Lysimeter sump leak test indicated a drop in the water level greater than 1/8-inch. The leak was determined to be around the pipe boot and outlet pipe fittings. The fittings were re-sealed with caulk and the liner was re-tested. The second leak test on the Top Lysimeter indicated the leak was repaired. Leaks were not observed during the leak test on the West Slope Lysimeter, and the water levels measured during the test did not indicate a drop greater than 1/8-inch. At the conclusion of each test, the water was released from the sumps and the underside of the PVC liner within the sumps was observed by the CQA technician. No evidence of leaking was observed from either lysimeter pan.

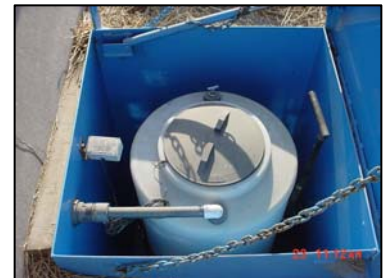
**Cover Drainage Measuring System Calibration:** The cover drainage lysimeter measuring system is comprised of a graduated, conical bottom, 55-gallon polyethylene tank, enclosed in a metal vault with locking metal lid. The tank is graduated in gallons and can be used to approximate large quantities of water.

Additionally, a dip stick is installed in the tank for water level observation. A RainWise tipping bucket rain gauge with an electronic data logger was mounted inside of the polyethylene tank to directly measure and electronically record water from the lysimeter pan outlet pipe. After tripping the bucket, water drains out the bottom of the rain gauge and accumulates inside the polyethylene tank. The electronic data logger records the number of tips, which can be correlated to an approximate volume of drainage through the cover. If the tipping bucket malfunctions, the graduated tank volume provides a backup reading.

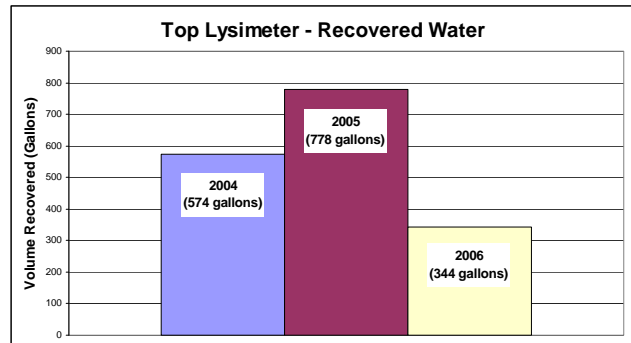
**Graph 13 – JCL Top Lysimeter Recovered Water**

The following graphs illustrate the precipitation and volume of water recovered in the Top Lysimeter for 2004 through 2006. As shown and as expected, the recovered volume fluctuates with respect to the amount of precipitation.

A significant volume of water has collected in the lysimeter tank each year (344 to 778 gallons). Based on visual observations and laboratory testing, the water was odiferous, rust-colored, and contained low levels of volatile organic compounds. These observations may indicate the water is not solely precipitation draining through the soil; rather it may be mixed with leachate or gas condensate.

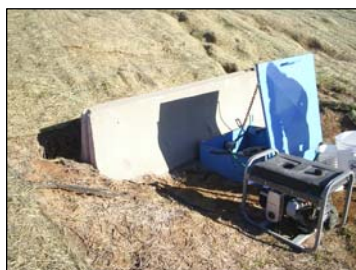
During the December 20, 2004 monitoring visit, the concrete jersey barrier located upslope of the lysimeter vault was discovered to have settled and sheared off the piping to the lysimeter vault. The jersey barrier was intended to reduce erosion and sediment

from covering the lysimeter vault. As a result of the settling and pipe shearing, the piping from the lysimeter pan was no longer connected to the lysimeter vault. The jersey barrier was removed and the piping repaired on December 28 and 29, 2004. The jersey barrier was replaced with a section of lighter corrugated metal piping.

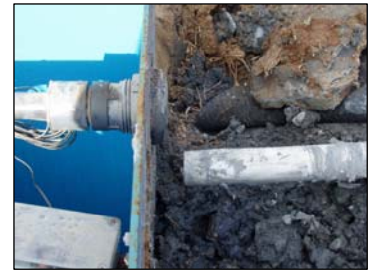
During the repair activities, the full piping length from the vault to the downslope edge of the lysimeter pan was uncovered and observed for cracks or damage. No cracks or damage were observed. However, the cover thickness over the downslope edge of the lysimeter pan was observed to be less than 5.5-foot thick. Therefore, following piping repair activities, additional materials were placed over this portion of the lysimeter pan and surrounding area. Subsequent surveyed elevations indicated the cover over the downslope edge of the lysimeter pan was greater than 5.5 feet thick following the addition of cover materials.

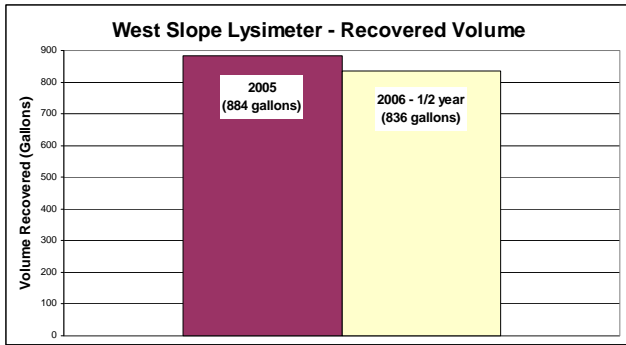
**Graph 16 – JCL West Slope Lysimeter Recovered Water**

The following graphs illustrate the precipitation and volume of water recovered in the West Slope Lysimeter for 2005 through 2006. It should be noted that since it is unknown when the damage to the piping occurred in 2004, the 2004 water recovery data may not be reliable, and was not included.
